MICROWAVE PATH SURVEY REPORT

RADIO FREQUENCY INTERFERENCE (RFI) MEASUREMENT REPORT

ViaSat

Transmit and Receive Earth Station
17-21 GHz and 27-31 GHz

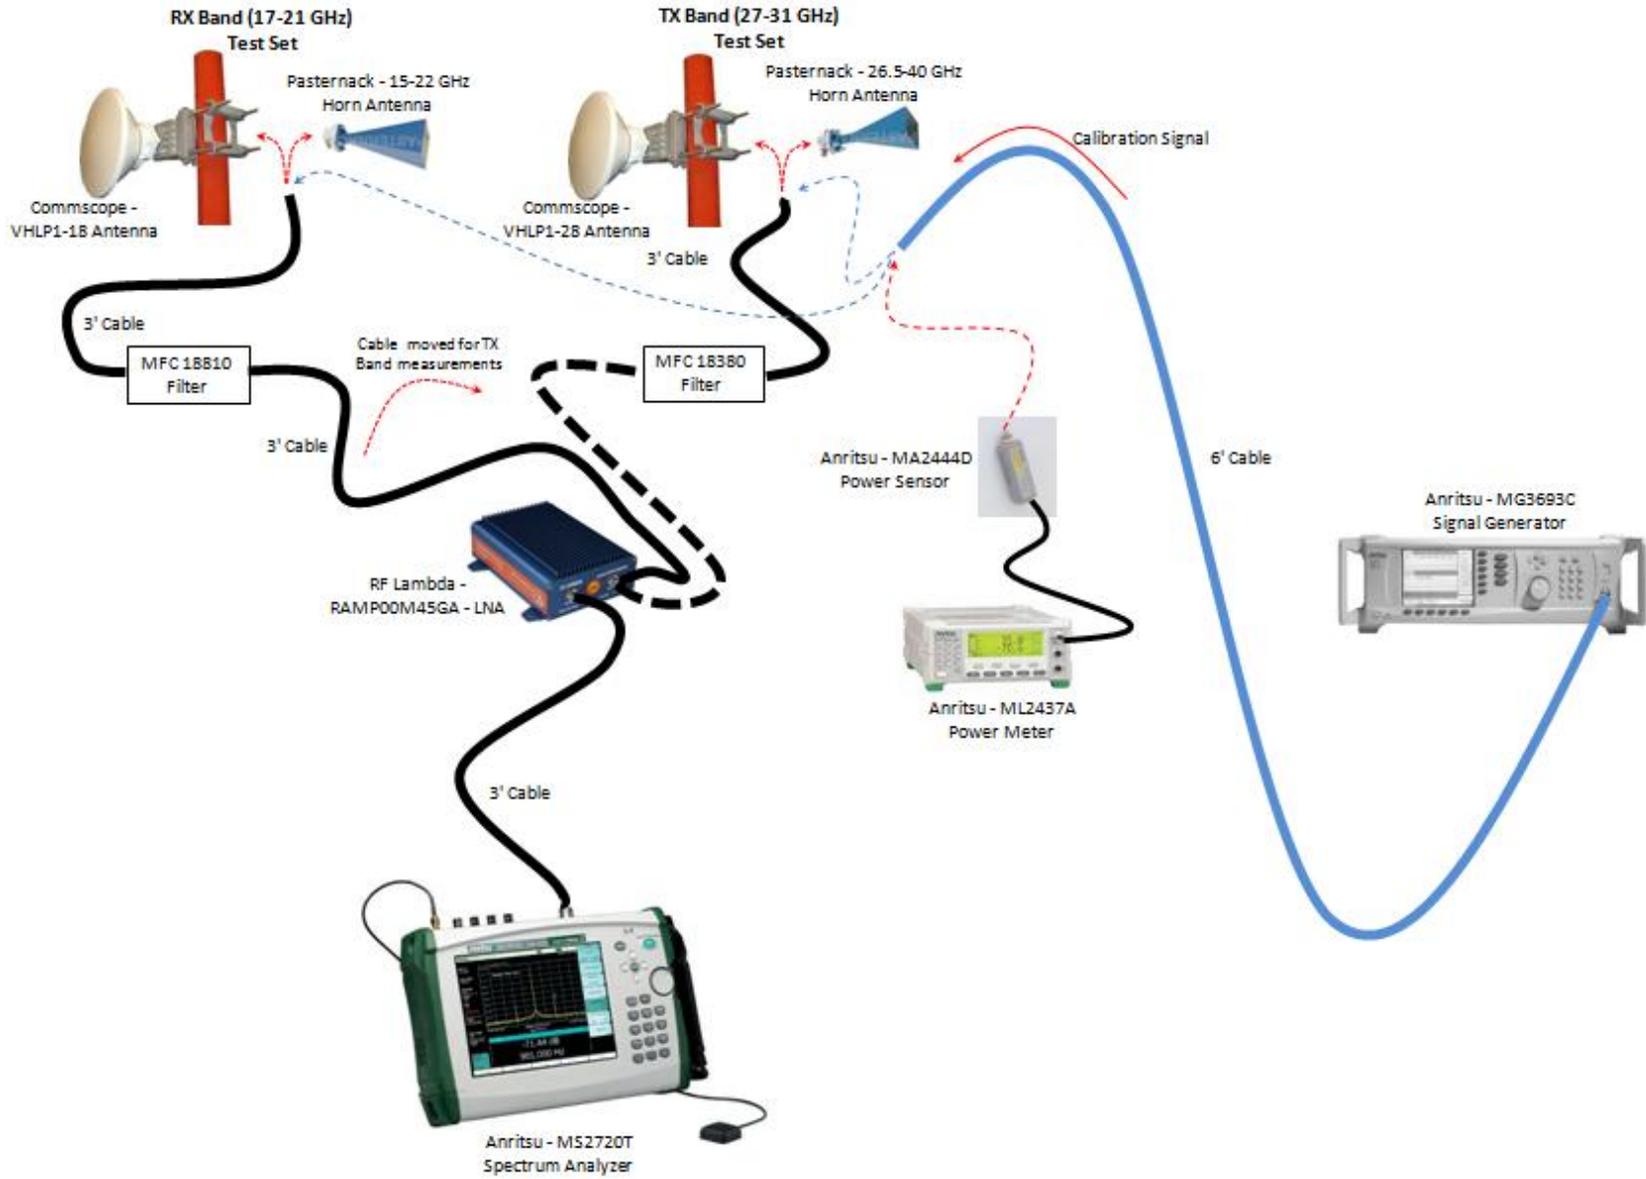
Figure 2.1-1 Receive Test Equipment Block

Figure 2.1-1 is the block diagram of the test set for all bands to be tested. All test equipment used was allowed a proper warm-up period prior to calibration. The test set was calibrated by the signal substitution method, as recommended by NSMA, utilizing a synthesized signal generator. The reference signal from the signal generator was adjusted for the center frequency of each band to be tested and measured with a thermal power meter for calibrated reference test level (-60 dBm). This calibrated reference signal from the signal generator was then injected into the end of the coaxial cable of the test set at the point, which normally connects to the test antenna. A spectrum analyzer then measured the reference test signal level after passing through the test set. At this point, the spectrum analyzer was calibrated such that the top graticule of the spectrum analyzer display (-60 dBm) corresponded to the injected reference signal (-60 dBm) by utilizing the reference level offset function of the Anritsu –M52720T spectrum analyzer. Upon completion of the calibration process, a known reference level was obtained for the measurements that correspond to a given set of spectrum analyzer display readings.

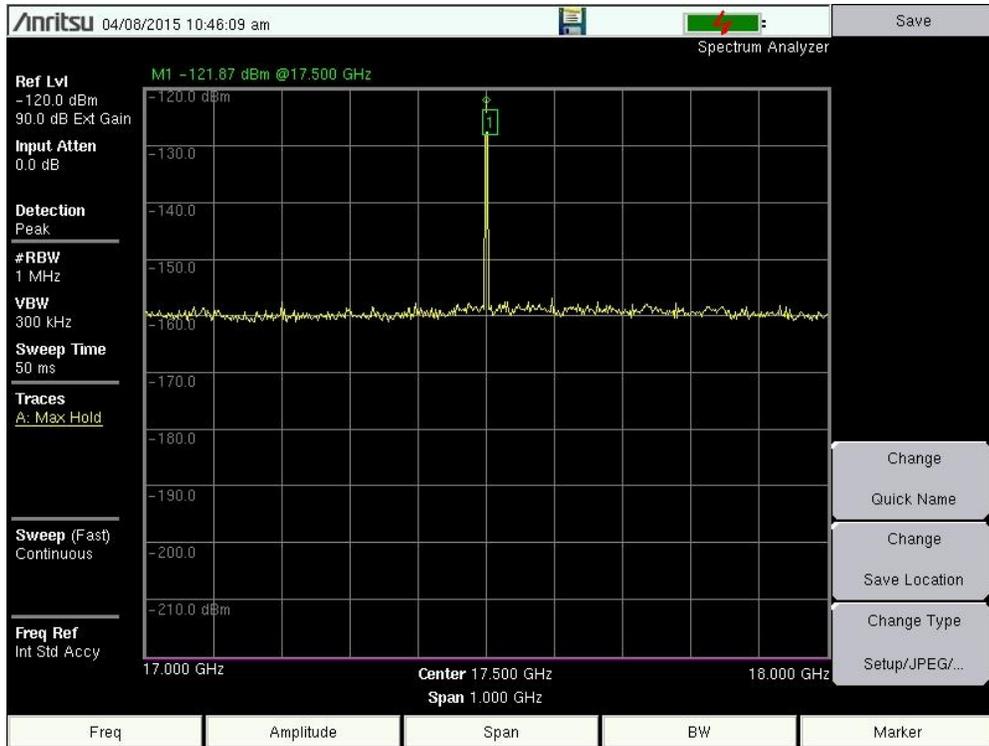
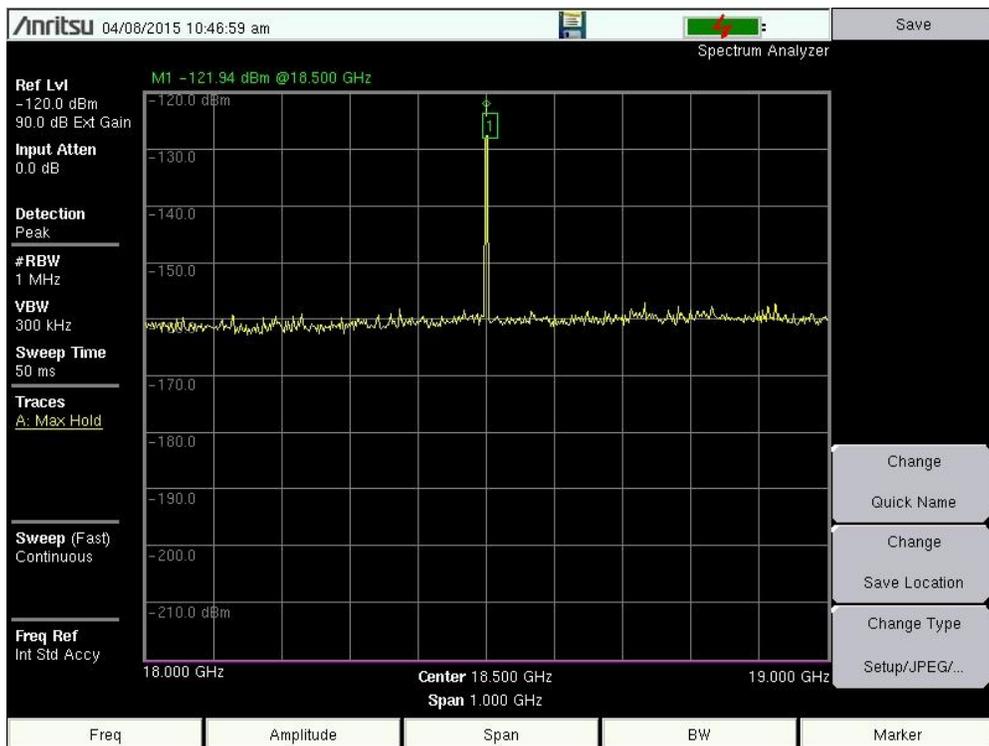
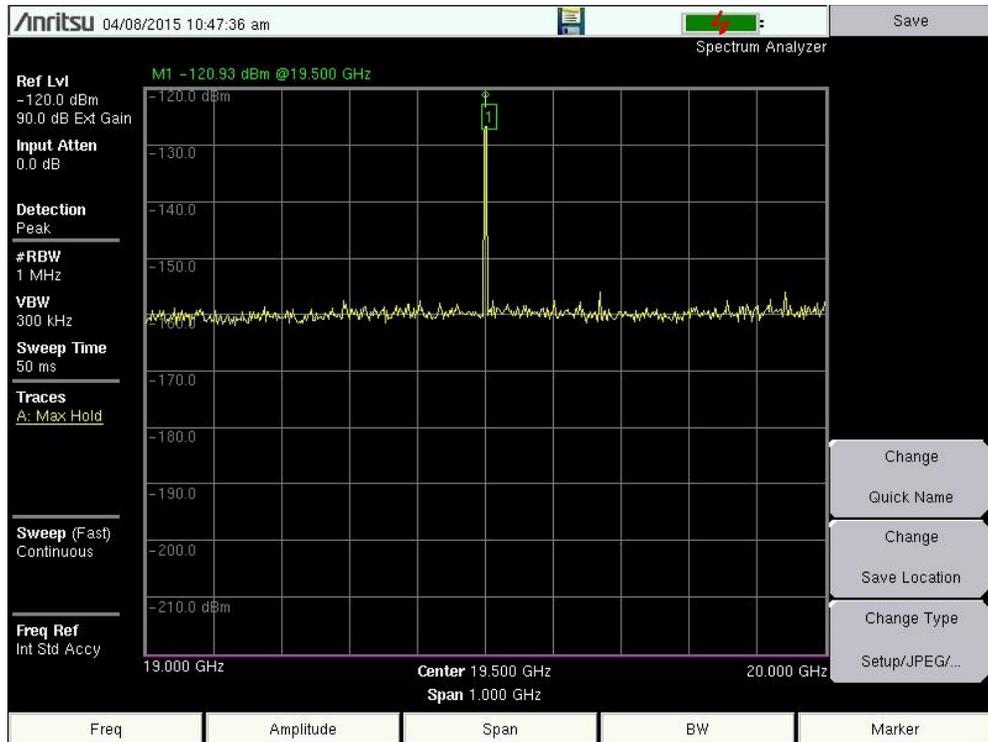
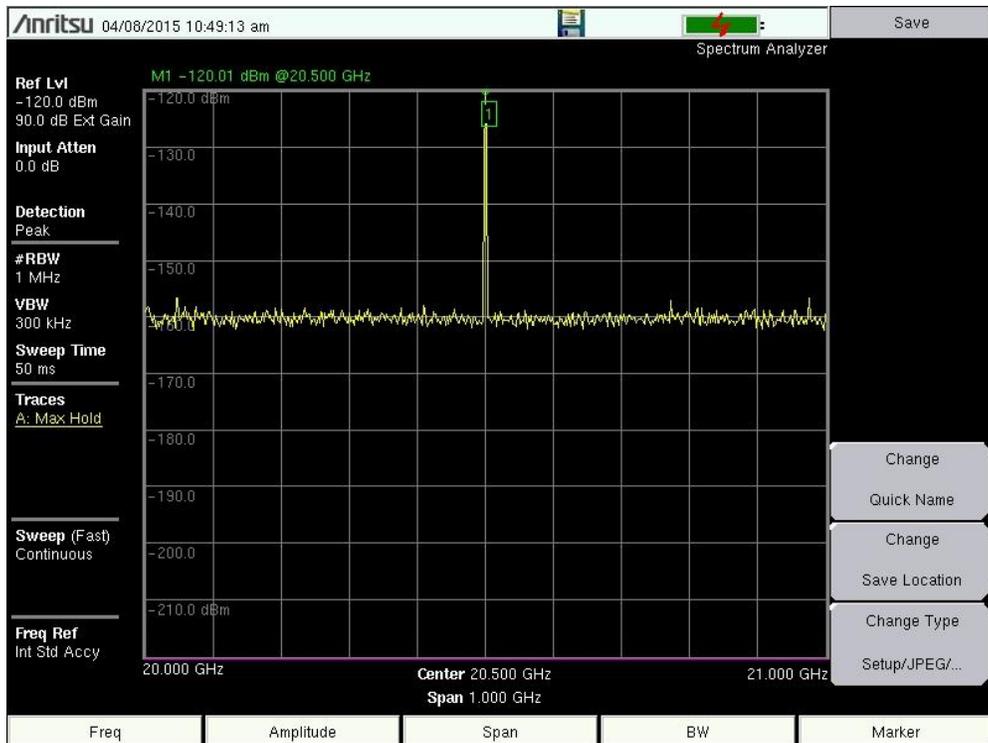
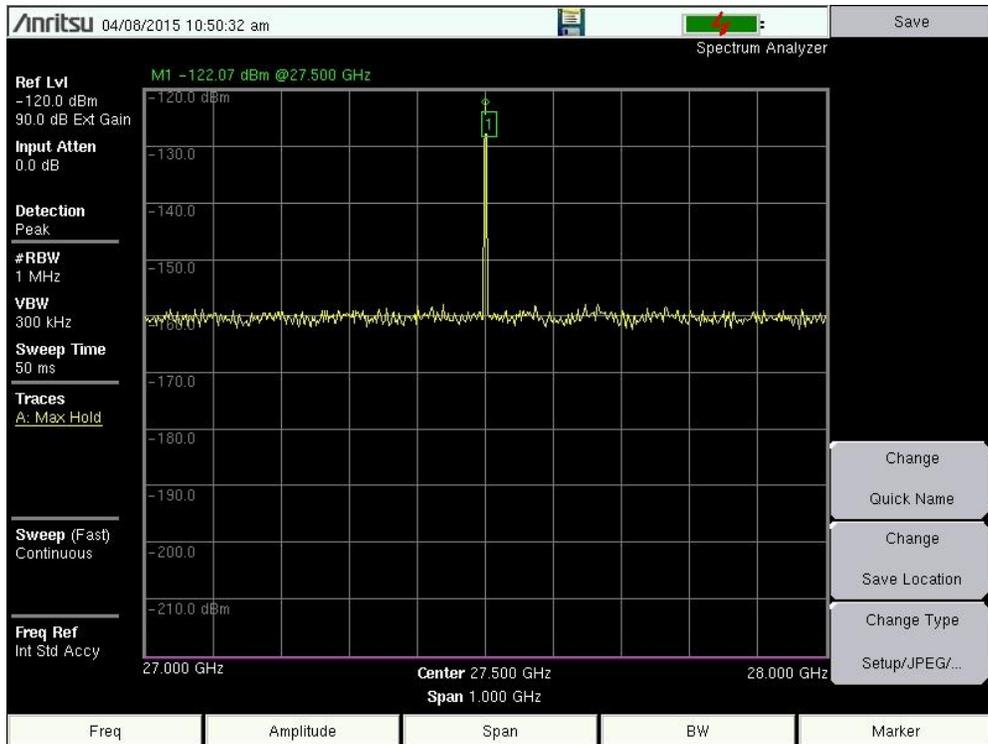
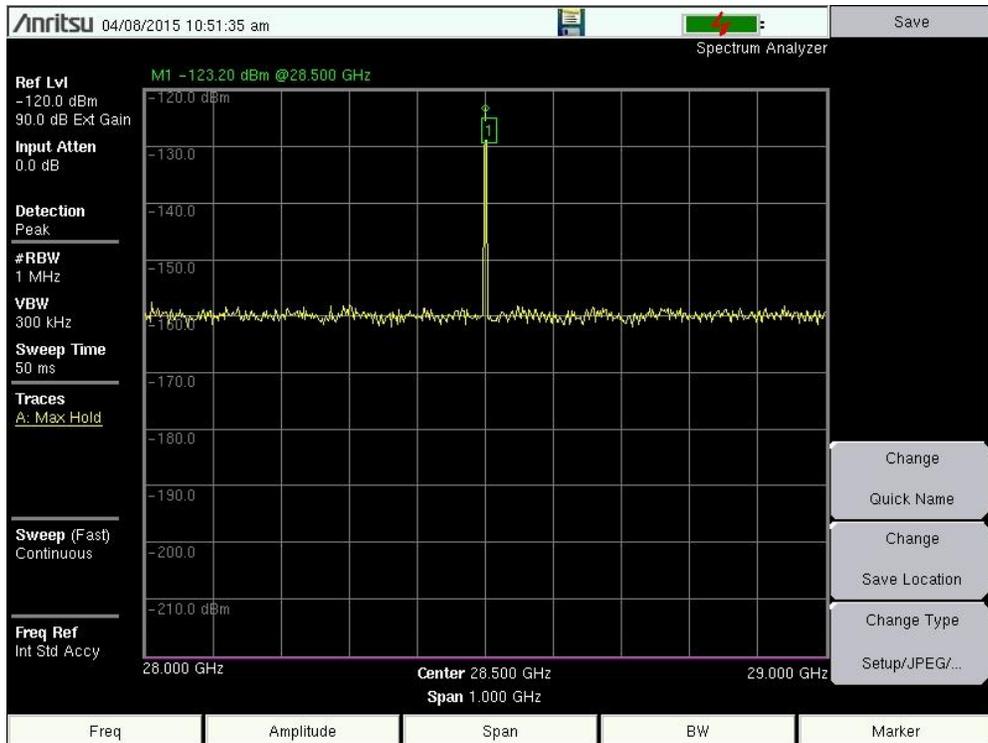
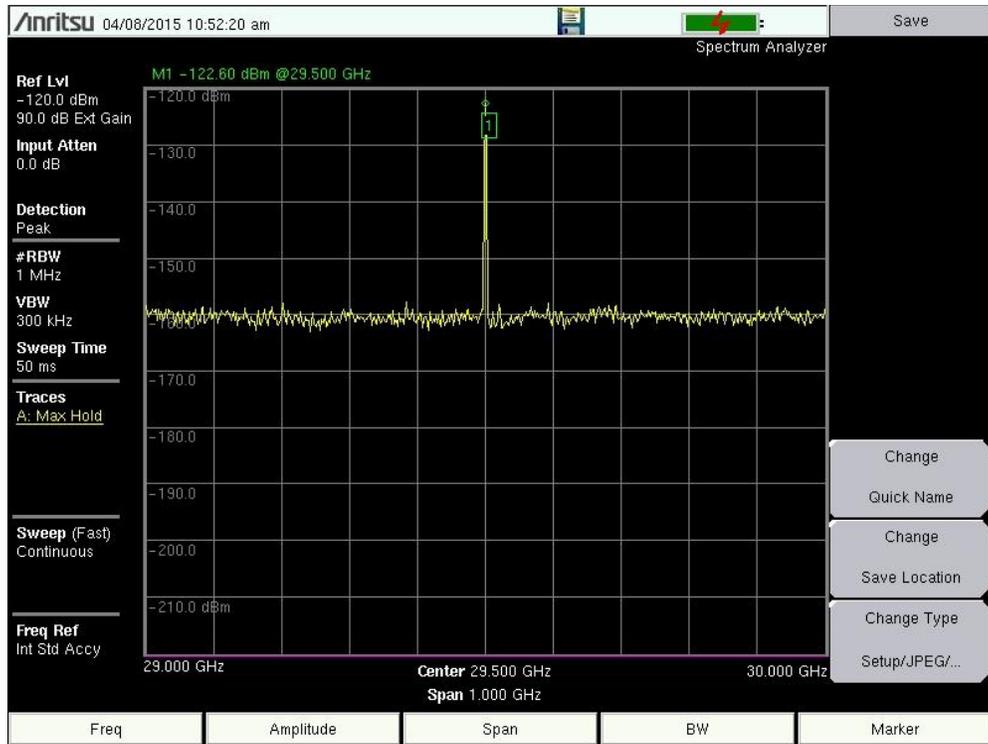
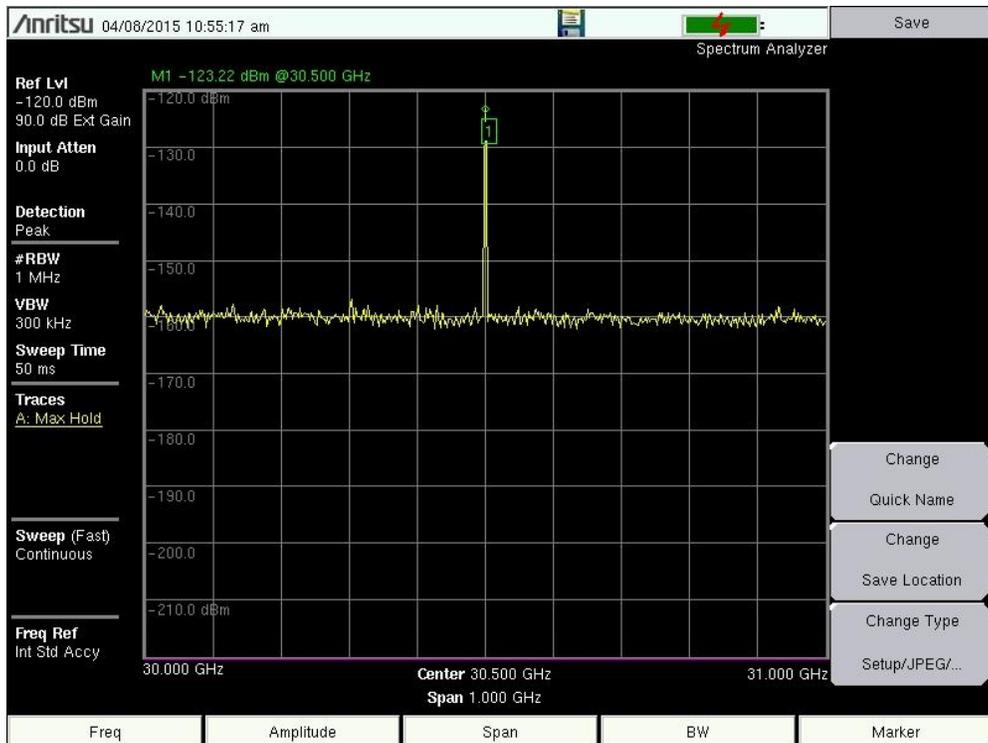
Figures 2.1-2(A-H) displays the spectrum photographs of the described calibration procedure employed during these measurements.

Figure 2.1-2 (A) Calibration Spectrum Photo 17.5 GHz

Figure 2.1-2 (B) Calibration Spectrum Photo 18.5 GHz

Figure 2.1-2 (C) Calibration Spectrum Photo 19.5 GHz

Figure 2.1-2 (D) Calibration Spectrum Photo 20.5 GHz

Figure 2.1-2 (E) Calibration Spectrum Photo 27.5 GHz

Figure 2.1-2 (F) Calibration Spectrum Photo 28.5 GHz

Figure 2.1-2 (G) Calibration Spectrum Photo 29.5 GHz

Figure 2.1-2 (H) Calibration Spectrum Photo 30.5 GHz

The following formula is used to transform the measured signal level as read on the spectrum analyzer display (dBm) to an isotropic reference signal level (dBW_I) as seen at the point of test:

$$\text{dBW}_I = \text{LI} - \text{GA} - 30$$

$$\begin{aligned} \text{at 19.5 GHz: } \quad \text{dBW}_I &= -60 \text{ dBm} - 30 \text{ dB} - 30 \text{ dB} \\ &= -120 \text{ dBW}_I \end{aligned}$$

In this instance, the spectrum analyzer displayed measured signal level of -60 dBm equates to an isotropic signal level of -120 dBW_I.

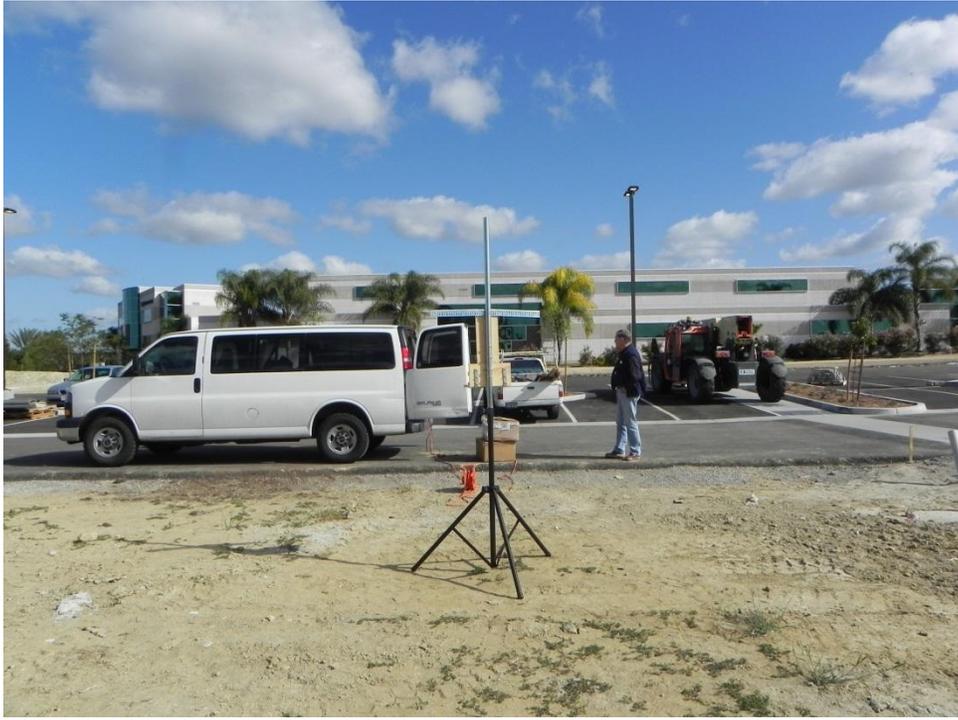
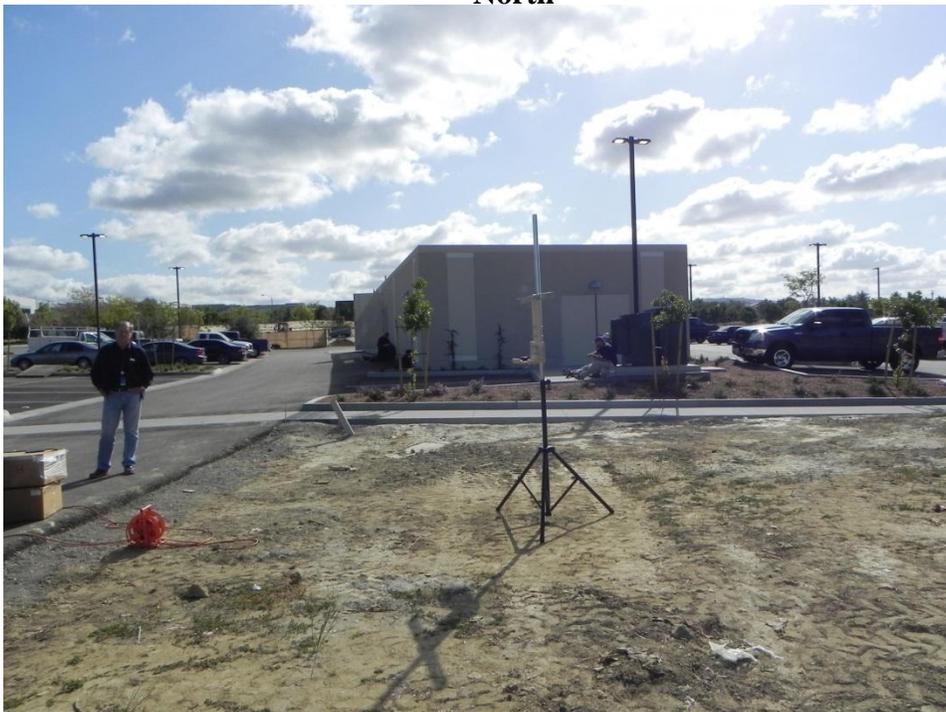
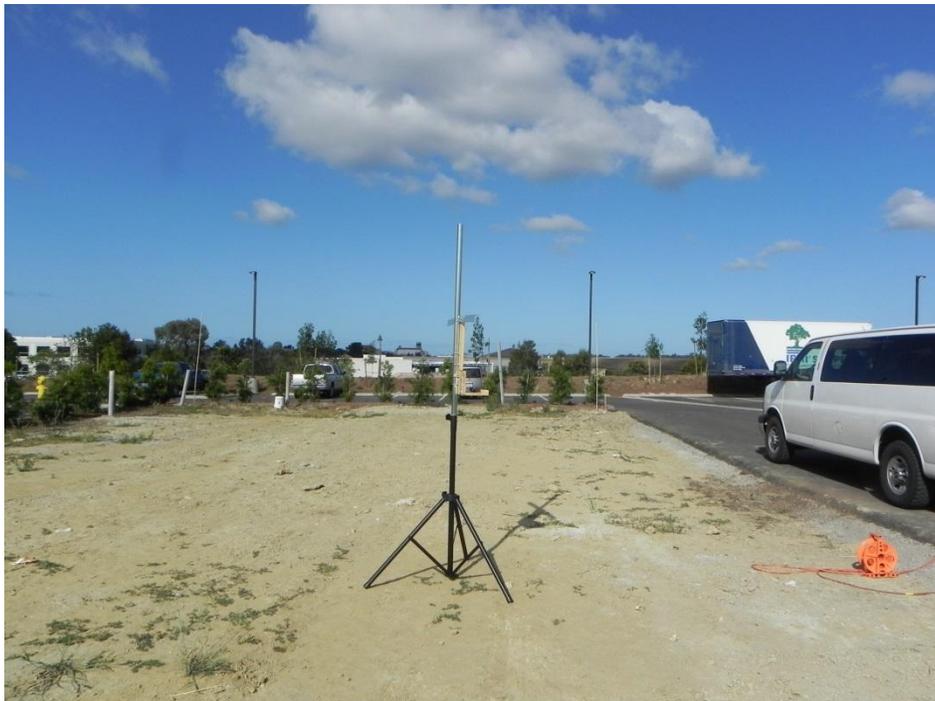
Figure 3.1-1 Earth Station Site Photographs

- Table 3.1-1 presents a site data sheet including all pertinent site information.
- Figures 3.1-1 and 3.1-2 are the photographs depicting the existing earth station site and satellite arc.
- Figures 3.1-3 through 3.1-10 are the RF spectrum photographs depicting the interference environment at the test site.

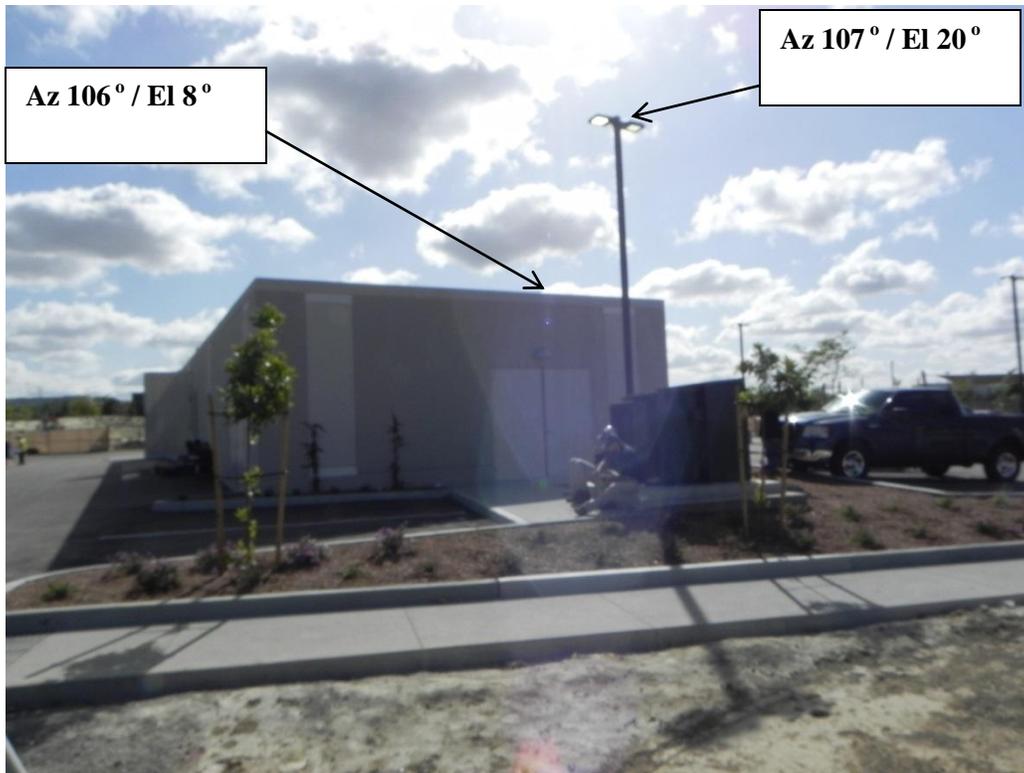
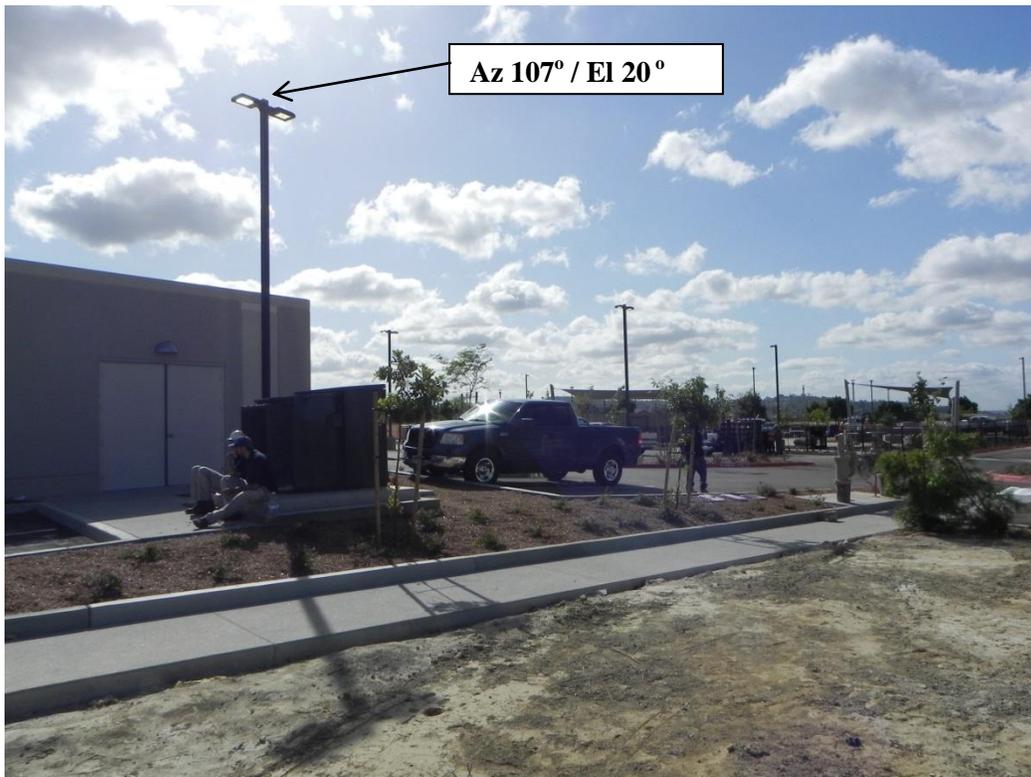
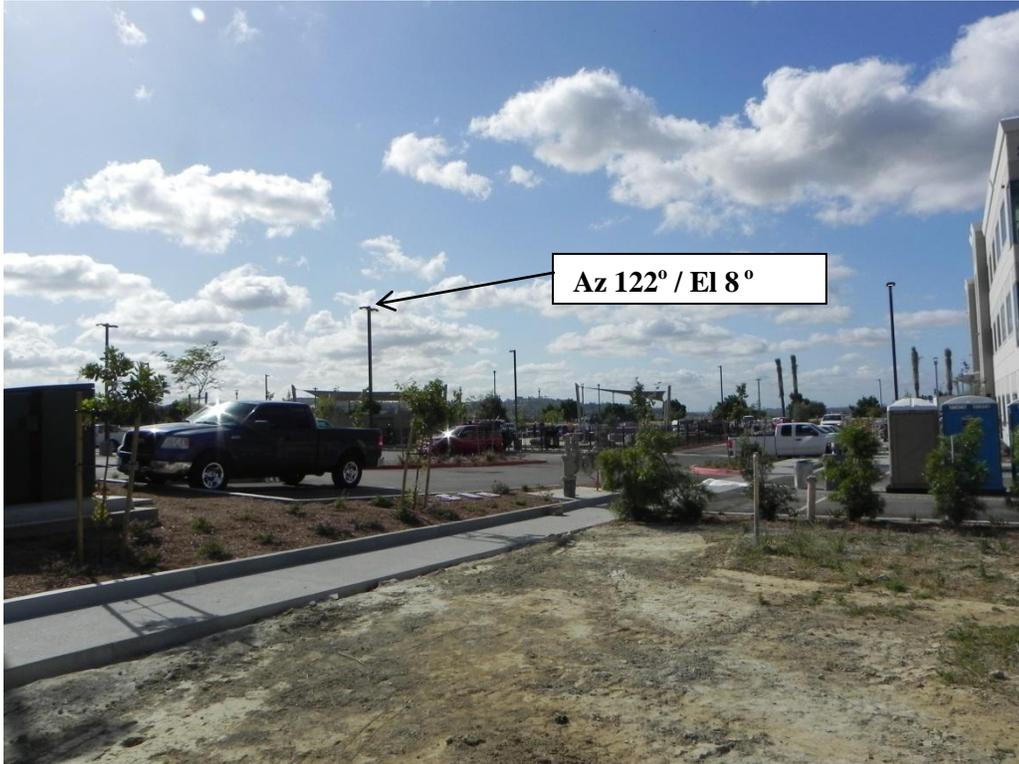
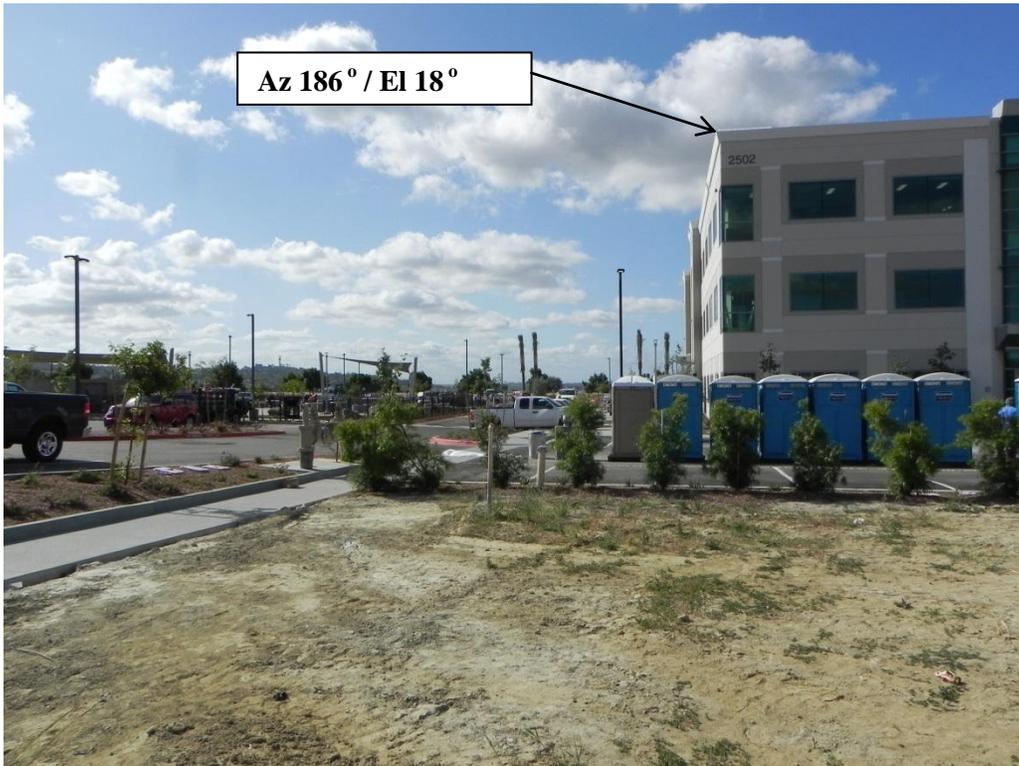
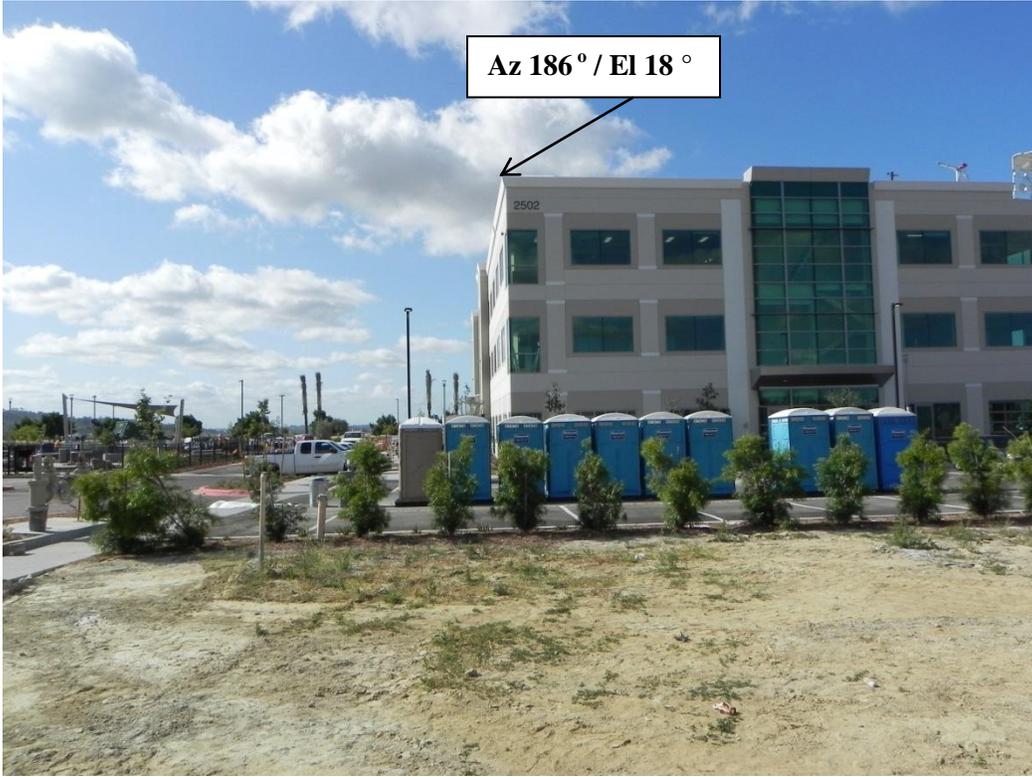
Figure 3.1-2 Horizon Photographs of Earth Station Site

There is no potential satellite arc blockage at this site. Final arc clearance will depend on antenna placement.

The satellite arc has no potential blockage from 55W through 115W.

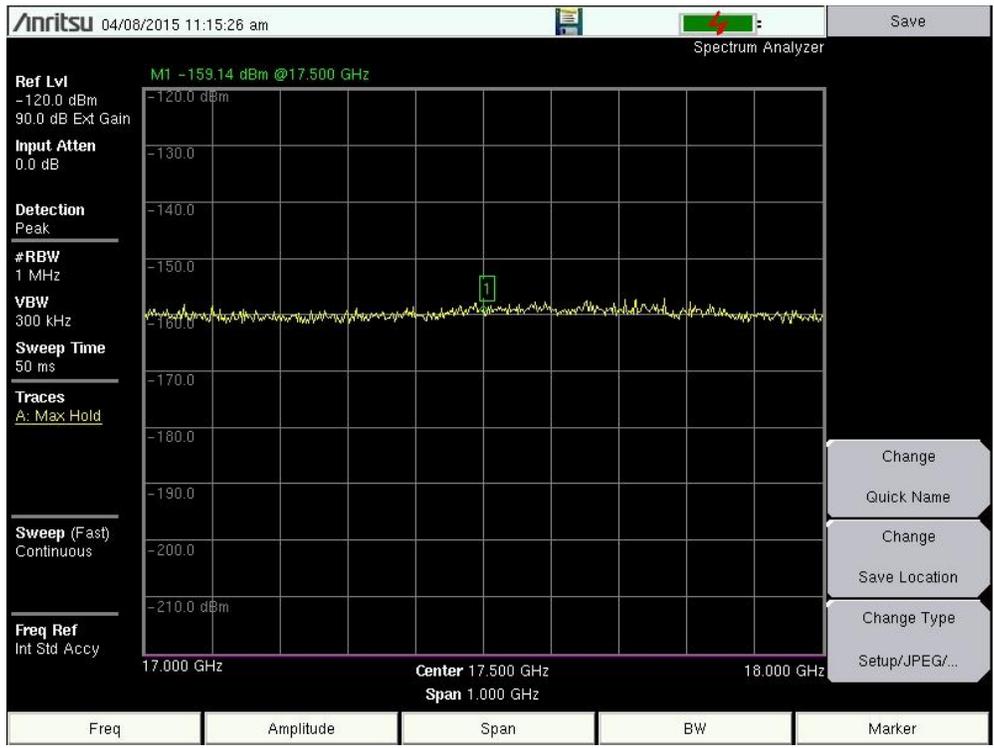
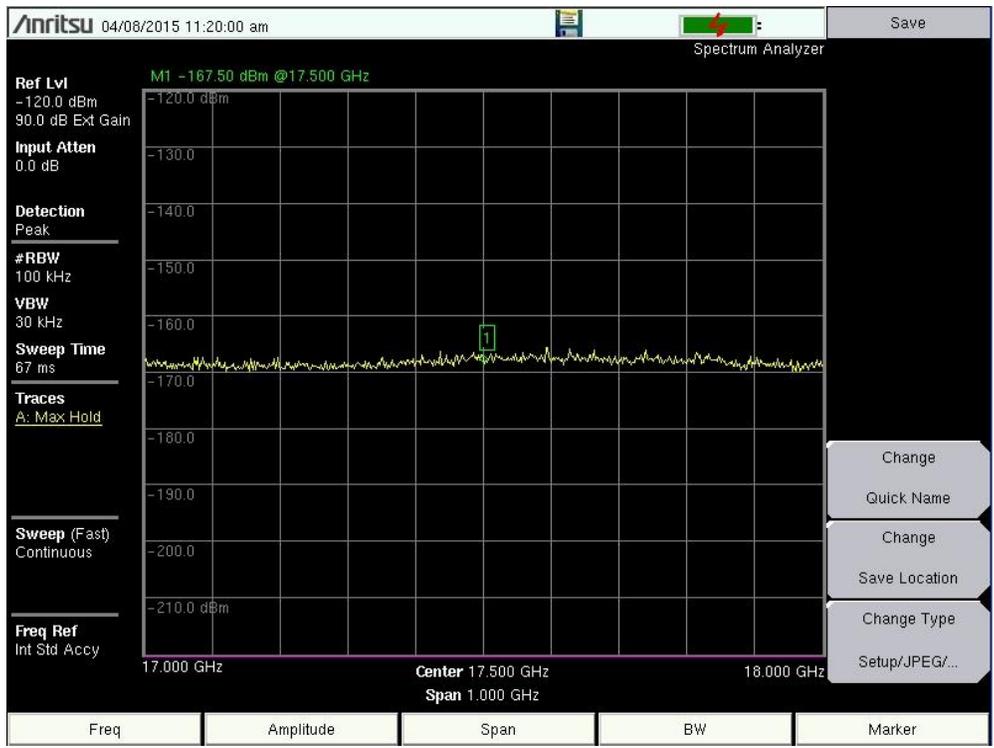
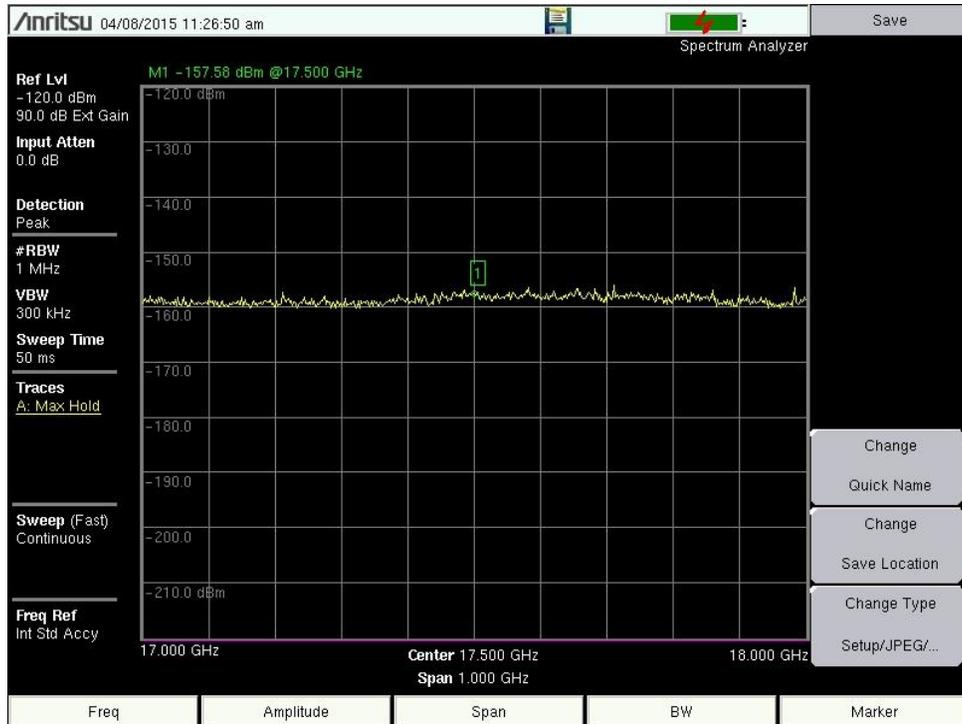
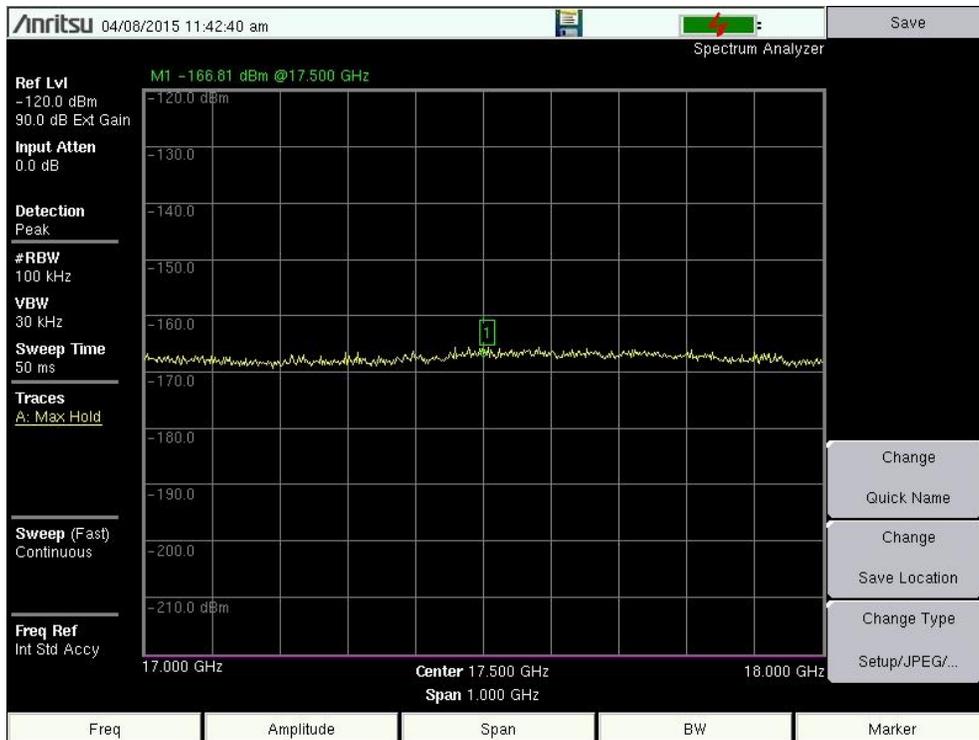
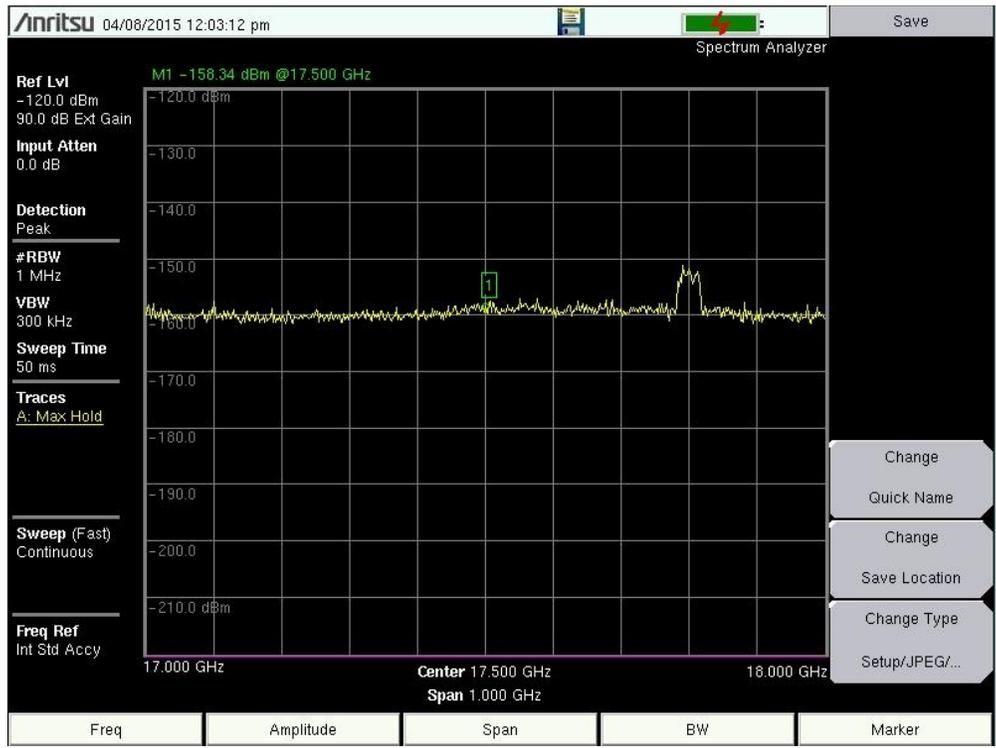
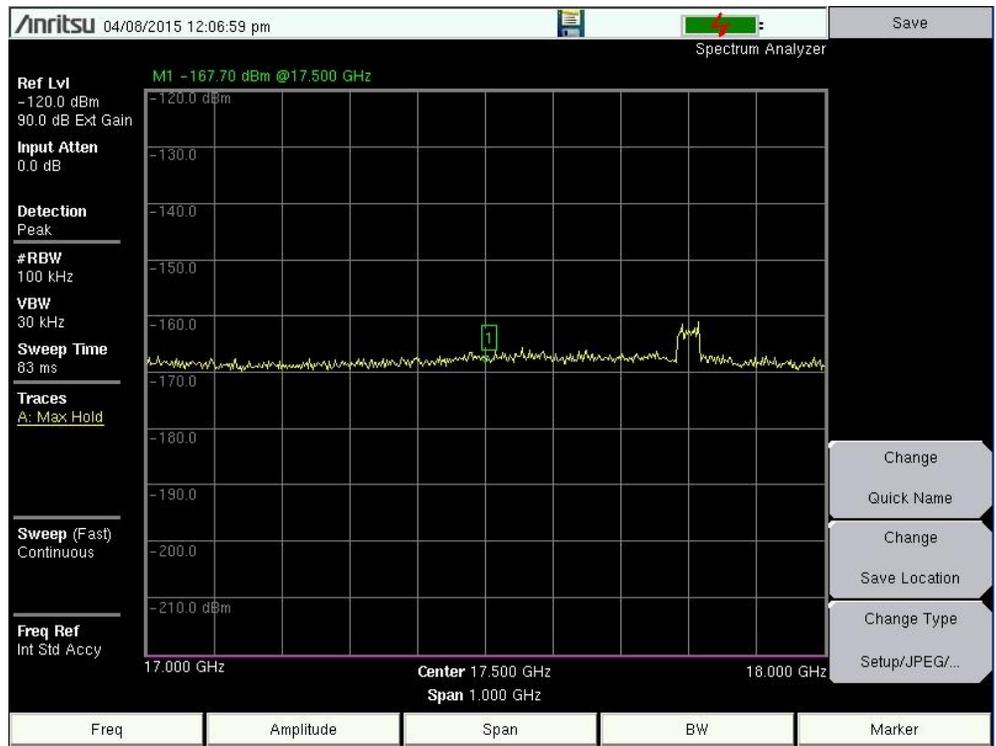
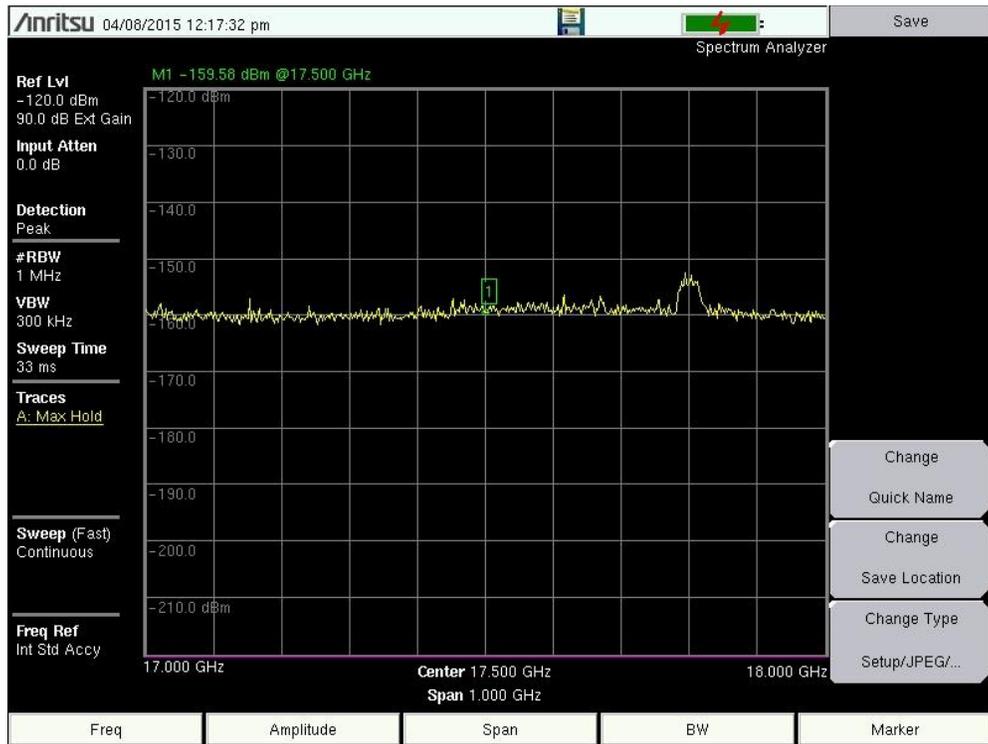
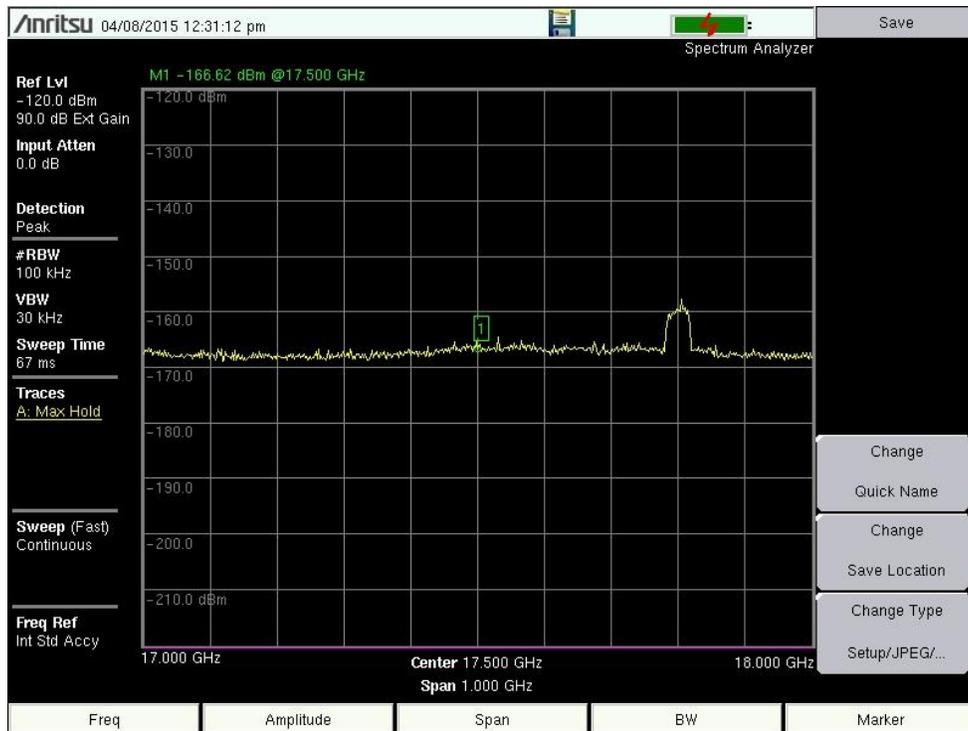
Figure 3.1-3 (A) Spectrum Photos 17-18 GHz 1MHz Res BW Horizontal Pol 360⁰

Figure 3.1-3 (B) Spectrum Photos 17-18 GHz 100 kHz Res BW Horizontal Pol 360⁰

Figure 3.1-3 (C) Spectrum Photos 17-18 GHz 1 MHz Res BW Horizontal Pol Worst Case

Figure 3.1-3 (D) Spectrum Photos 17-18 GHz 100 kHz Res BW Horizontal Pol Worst Case

Figure 3.1-3 (E) Spectrum Photos 17-18 GHz 1MHz Res BW Vertical Pol 360⁰

Figure 3.1-3 (F) Spectrum Photos 17-18 GHz 100 kHz Res BW Vertical Pol 360⁰

Figure 3.1-3 (G) Spectrum Photos 17-18 GHz 1 MHz Res BW Vertical Pol Worst Case

Figure 3.1-3 (H) Spectrum Photos 17-18 GHz 100 kHz Res BW Vertical Pol Worst Case

There were signals measured above the -156 dBW/ 1 MHz interference objective for digital reception at this site. These signals were predicted in the Comsearch Detailed Interference Analysis report. The signal detected is identified as LK SAN MARCOCAST and is transmitted at 17800 MHz. The second carrier at 17900 MHz was not detected and may either be blocked or not transmitting at the time of the measurement.

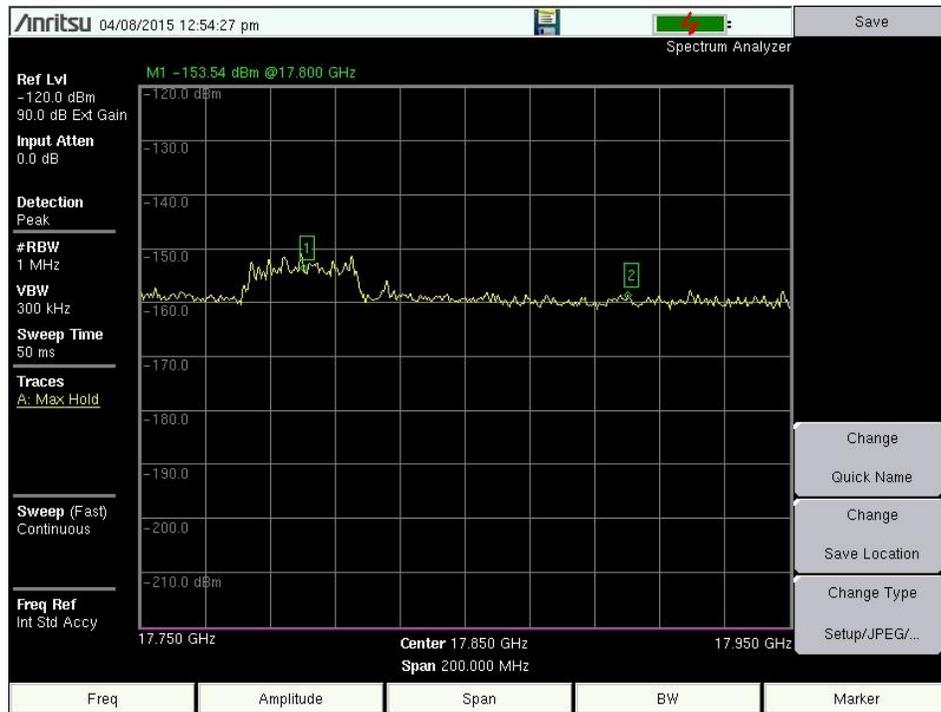
Capture 1A Spectrum Photos 17.75 – 17.95 GHz 1MHz Res BW Interfering Carriers

In Capture 1A above, the carrier shown at marker 1 is associated with MARCOASST with a frequency of 17800 MHz from azimuth 107 degrees. This was predicted in the Detailed Interference Report for this test location.

The frequency at marker 2 of 17900 MHz was also predicted in the same report as MARCOCAK1 however no transmission was detected at any time during this measurement. Capture 1B is a look at the same transmission at 17800 using a narrower span and RBW of 100 kHz for clarity.

It is recommended that frequency coordination of this site be initiated to protect this location at the more stringent digital receive interference objective.
